MEMORANDUM

SUBJECT: 167205008 -- Sangamon County
Springfield/Fiat Allis
Superfund/Site Inspection

On March 24, 1987 a site inspection was conducted at Fiat Allis in Springfield, Illinois. This inspection was done under the authority of CERCLA on behalf of the USEPA. Mr. James Condra and Mr. Richard Fix representing Fiat Allis and Greg Kugler representing Andrews Environmental Engineering, Inc. was interviewed. Rick Lanham, DLPC/FOS-Central Region and Greg Dunn, DLPC/PA-SI Unit accompanied me on this inspection.

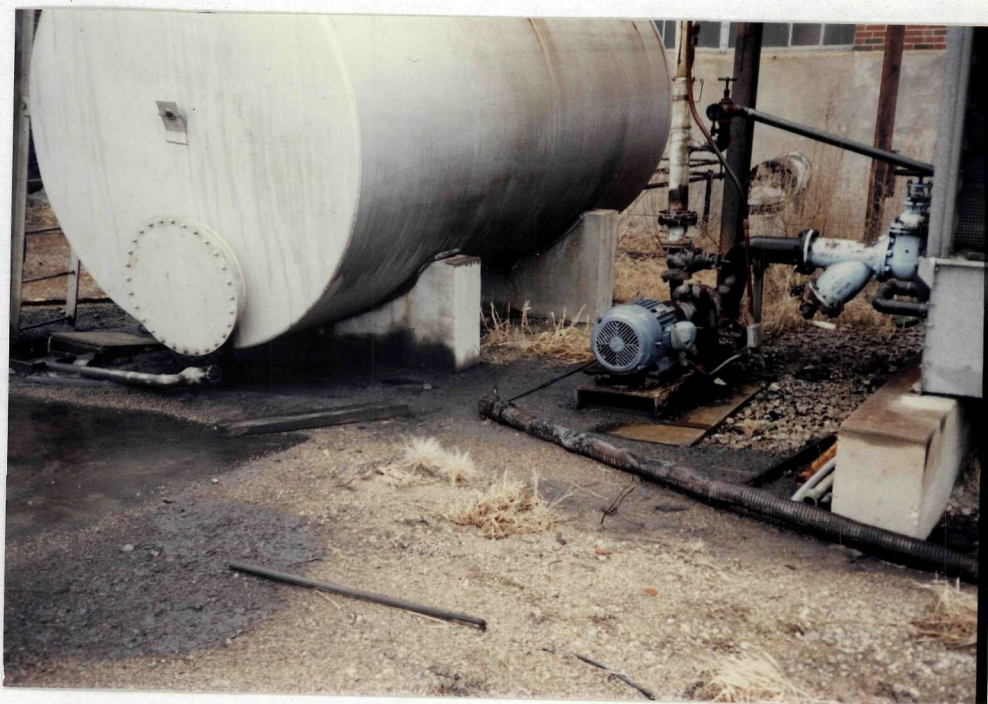
Between the time of 11:20 and 11:25 a.m., sample monitoring point number X101 was collected. The sample was collected from the west side of the powerhouse. The sample was taken at a depth of 0 to 2 inches. The soil had visible oil stains. The sample was collected by Ken Page and evidenced taped by Greg Dunn at 11:25 a.m.

toward the East; sample
monitoring point X101, waste storage/
mixing tank outside of the
Powerhouse

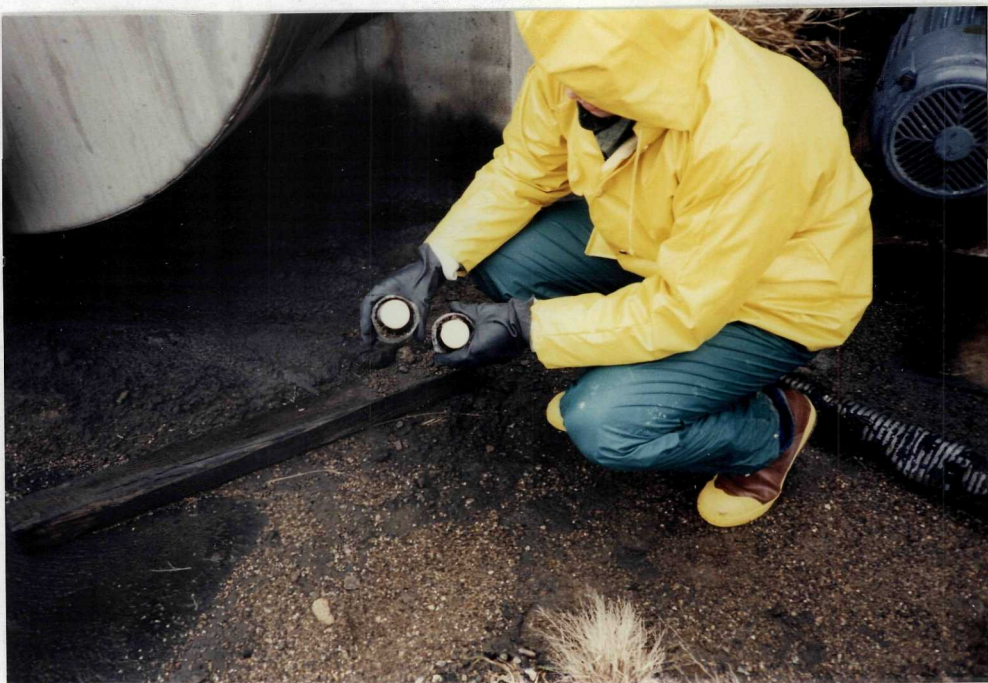
toward the East; Greg Dunn
holding sample (2 bottles) X101

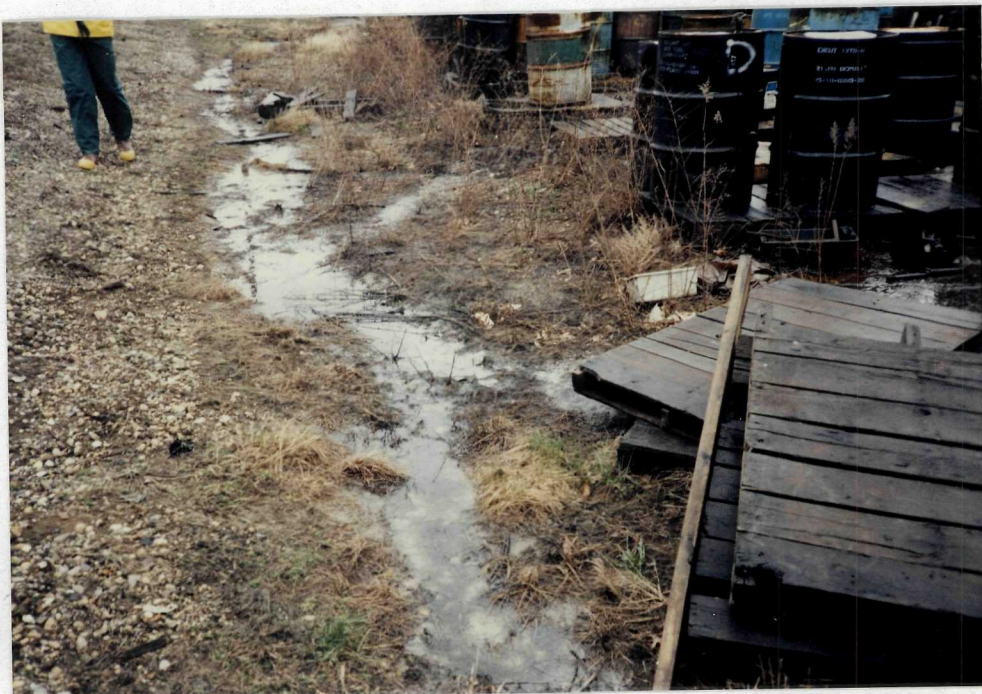
Between the time of 11:35 a.m. and 11:45 a.m. sample monitoring point number X102 was collected. This sample was taken west of the outdoor drum solvent storage area. Along the west side of this storage pad (concrete), a visible oil sheen on the water was noticed flowing off this pad along the ground and ponding. Sample was collected from 0 to 4 inches. Some of the soil sample contained oil that had flowed off the storage pad. This sample was collected by Ken Page and evidenced taped by Greg Dunn at 11:45 a.m.

toward the North; water draining
from the outdoor drum solvent
storage area

Note: Water Run-off from the drum solvent storage area

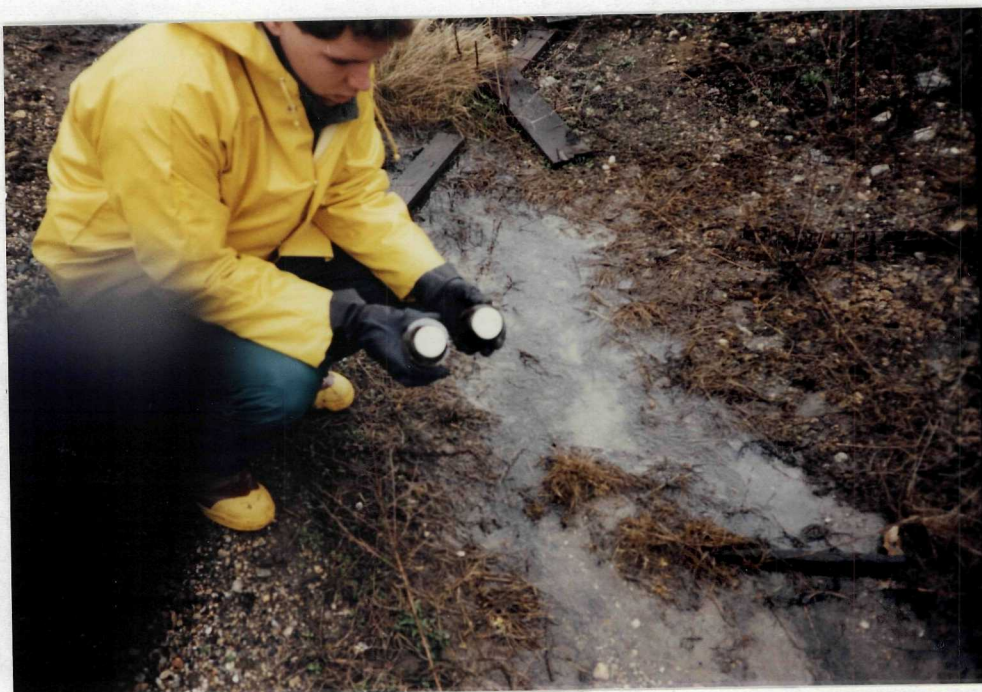
toward the North; Greg Dunn
holding sample (2 bottles) X102,
taken west of the outdoor
drum solvent storage area

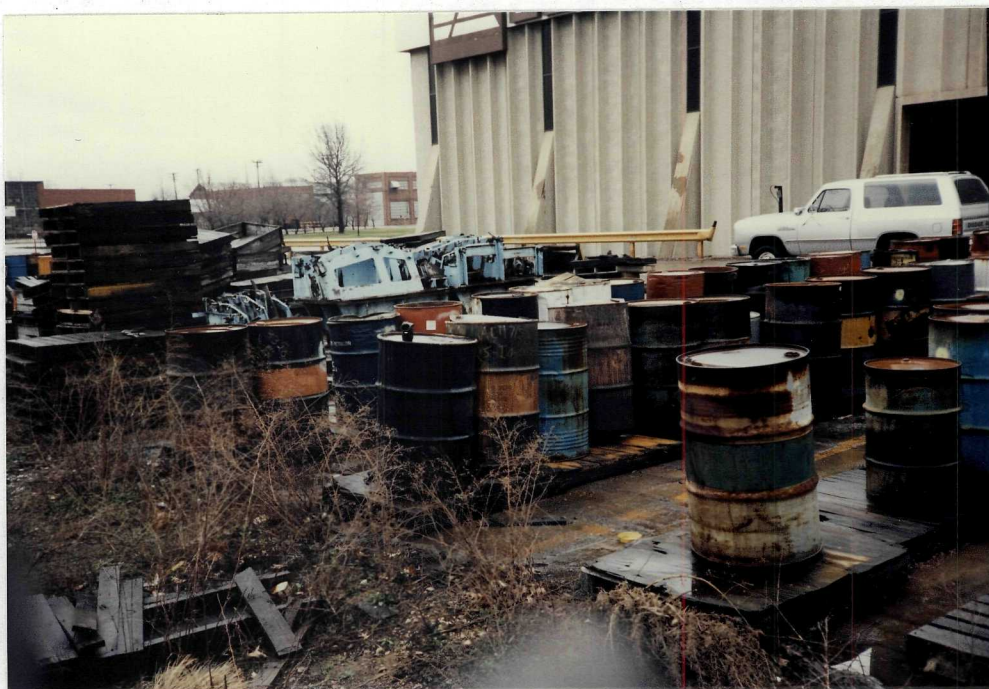
It was learned from the conference that Fiat Allis had stored drums that contained solvents and solvent residues outside. Rick Lanham questioned this practice and Fiat said that it was at the request of the fire department that they store the drums outside. The said reason for this storage was to decrease the chances of the drums exploding or catching fire inside the building. These drums are stored outside of building no. 77. Some of the drums had bungs and tops missing. All the drums were exposed to the elements without any protective cover.

toward the NE; Outdoor drum
solvent storage area, building
to the east is building no. 77

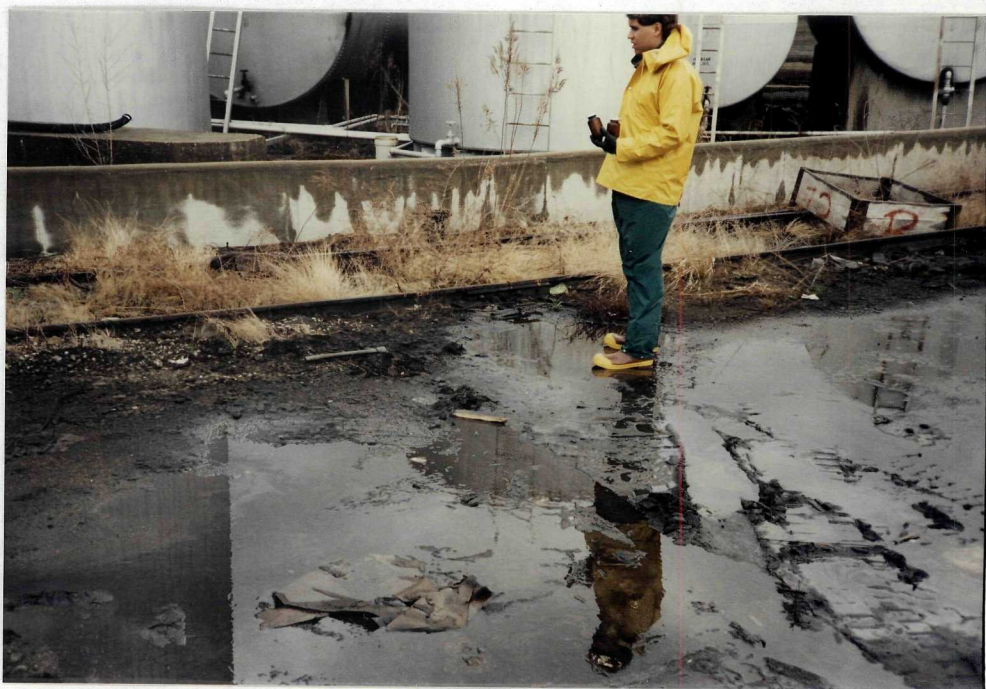
toward the SE; Greg Dunn
standing west of the fuel tank
storage area

Note: Oil and Water ponded

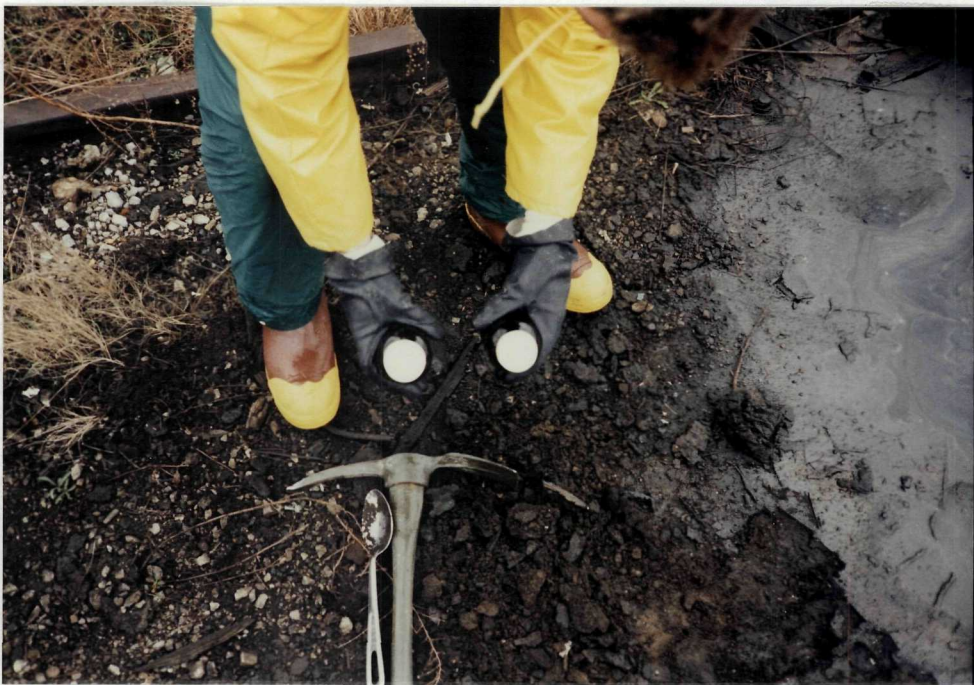
Between the time of 12:10 p.m. and 12:15 p.m., sample monitoring point number X103 was collected. This sample was collected west of the fuel tank storage area. The sample was collected at a depth between 0 and 2 inches. The area of sampling was covered with oils, could have occurred from the loading and unloading of tanks. Sample was collected by Ken Page and evidenced taped by Greg Dunn at 12:15 p.m.

toward the East; sample monitoring
point X103, collected west of the
fuel tank storage area

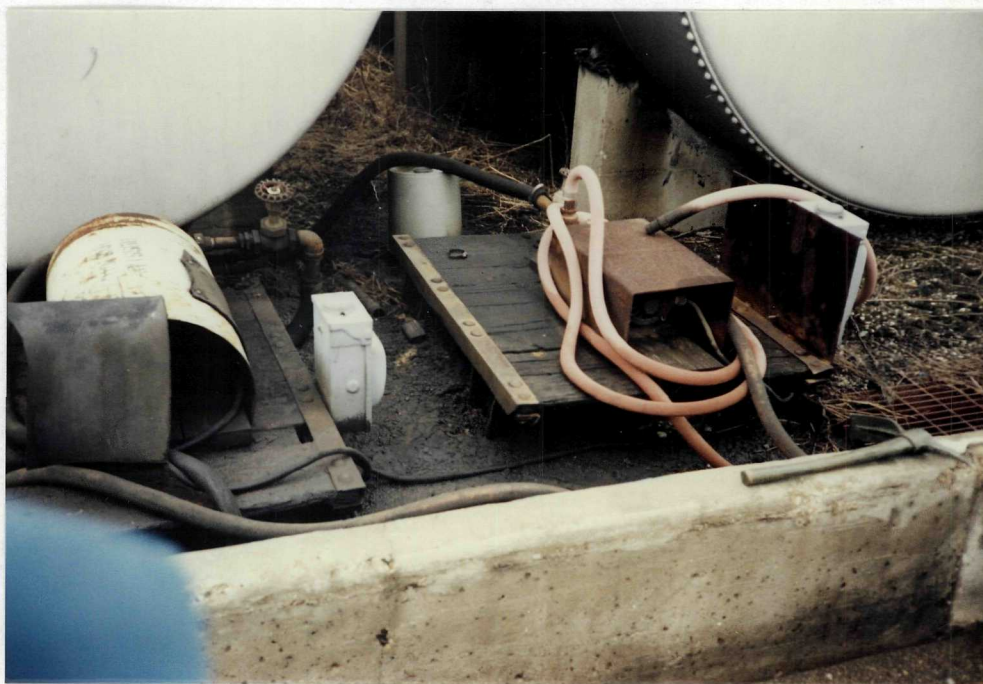
toward the West; fuel tank
storage area is surrounded
by a concrete berm.

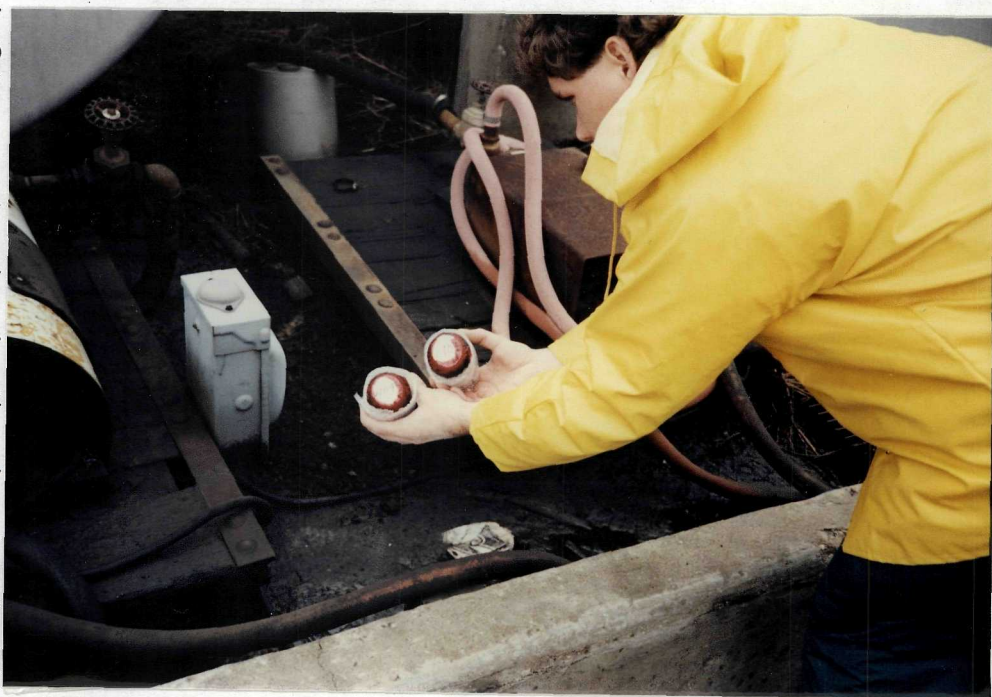
Between the time of 12:20 p.m. to 12:30 p.m. sample monitoring point number X104 was collected. This sample was collected within the fuel tank storage area. Sample was collected at a depth of 0 to 5 inches on the east side of the storage tanks. Sample was collected by Ken Page and evidenced taped by Greg Dunn at 12:30 p.m.

Comments: Photograph taken
toward the West; sample
monitoring point X104, collected
inside bermed (concrete) area.

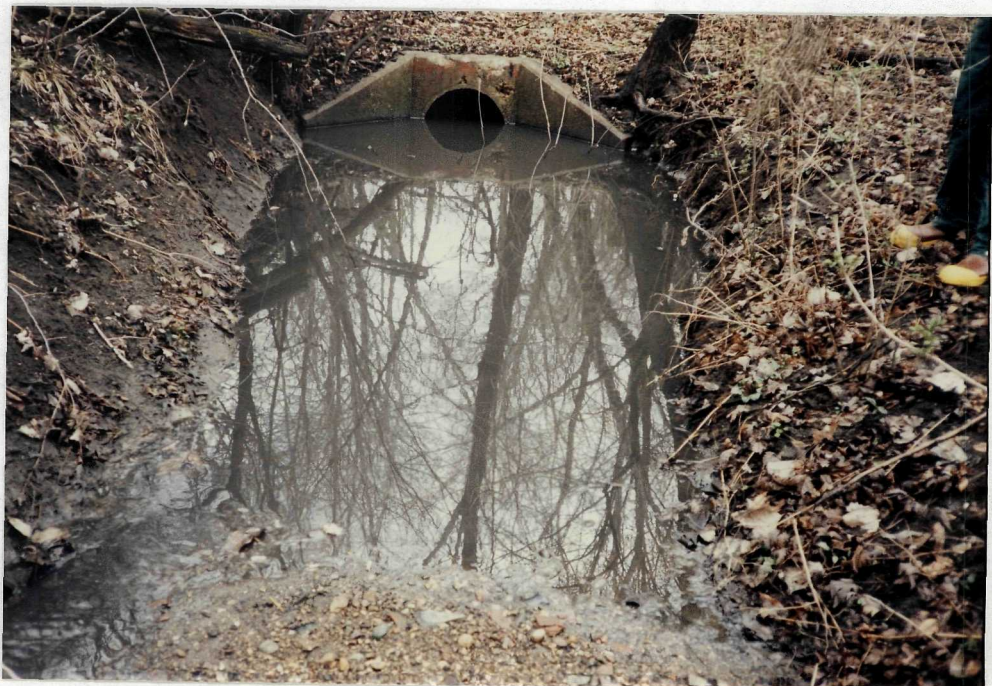
The above four sampling monitoring points (X101, 102, 103 and 104) were the only samples taken on Fiat's property. We left the site at 12:40 p.m. and inspected the storm sewer south of Fiat's Engineering Building. The storm sewer appeared to be clean. After leaving the site we traveled along the railroad right-of-way behind the U-Haul facility to inspect a storm sewer outlet to an unnamed tributary of Lake Springfield. Upon locating this outlet we noticed that it was discharging oil and had been doing this for quite some time. Greg Dunn and myself collected a water sample, no VOC's were collected. We collected the sample at 1:10 p.m. and evidenced taped the sample at 1:20 p.m. The oil had a diesel fuel smell in nature.

Comments: Photograph taken
toward the North; storm sewer
discharge south of Fiat Allis.
Oil is being discharged into
this unnamed tributary to Lake Springfield

After we returned to the office we notified Jim O'Bryan of the Emergency Response Unit about the oil incident. O'Bryan contacted Bud Bridgewater of the WPC/FOS about the oil occurrence. O'Bryan is handling the problem.

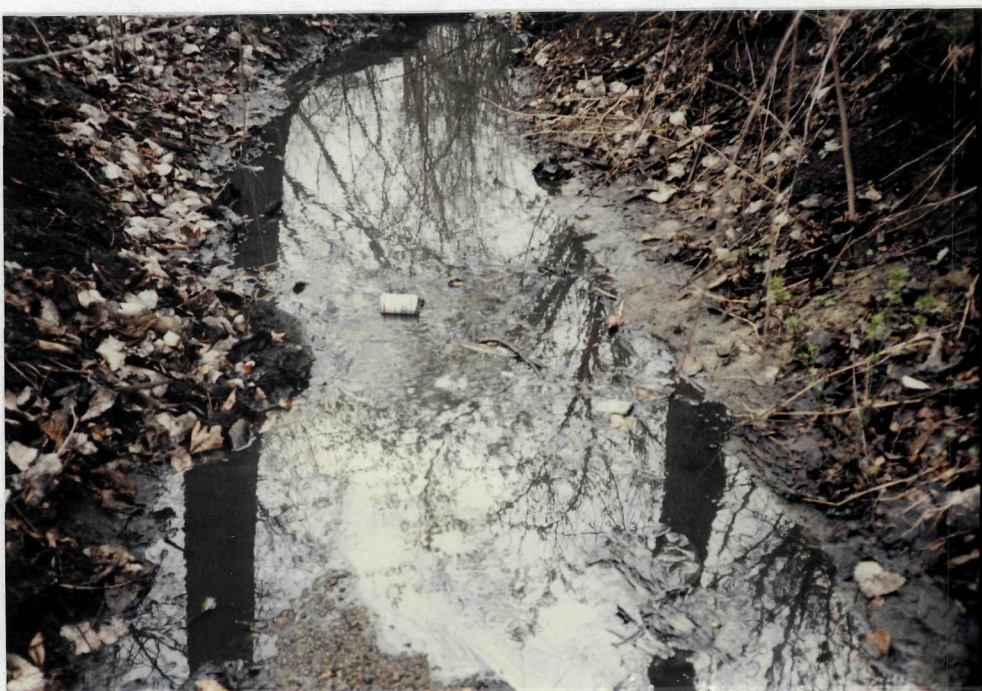
Comments: Photograph taken
toward the North; unnamed
tributary to LAKE Springfield

NOTE : Oil SHEEN ON WATER
